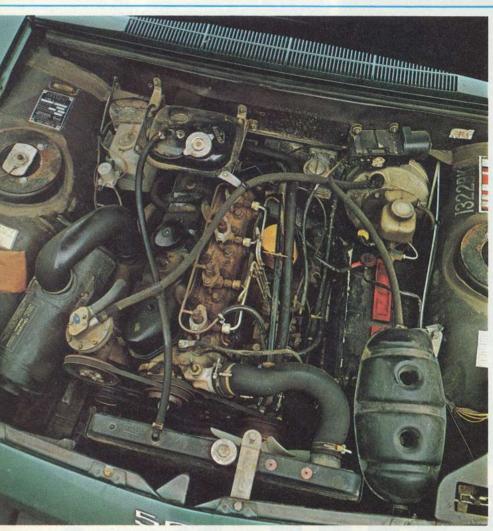
504 diesel arrived at teardown appointment with generous layer of sand atop engine, thanks to Palm Springs, California sandstorms.

Near the conclusion of the test the car was caught in one of Palm Springs, California's, notorious sandstorms resulting in severe pitting of the windshield and frosting the headlamp lenses and the glass in the outside rearview mirror, but the paint held. And although the engine and engine compartment looked as if someone had piled sand in with a shovel, the various filters provided complete protection for the fuel system and engine.

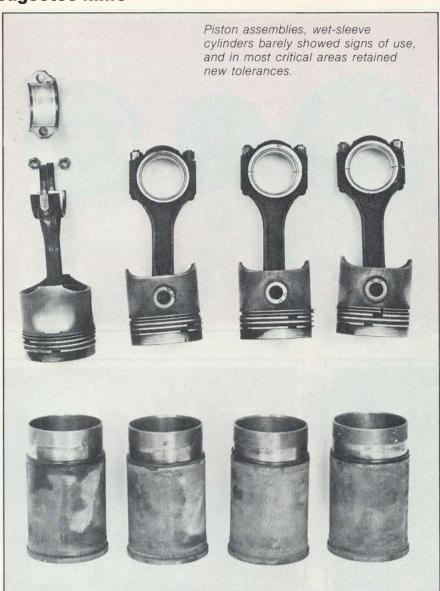
On removal of the aluminum cylinder head, the appearance of the combustion chambers was quite different from that of gasoline engines. There was a thin, soft, sooty, black film of carbon everywhere. Peugeot says this is typical and normal and that combustion chamber deposits don't build up with mileage in diesel engines the way they do in most gasoline engines. This self-cleaning action accounts no doubt for the smoke seen at times in diesel exhausts.

Thin, soft deposits on piston top are normal and represent maximum accumulation regardless of mileage.

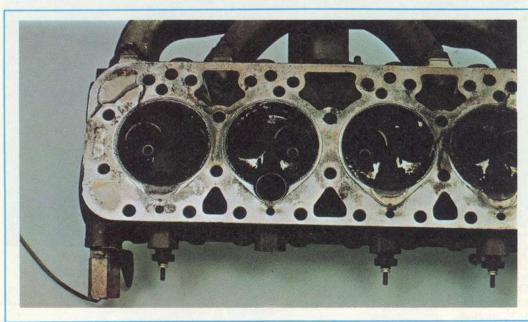
Opening a swirl chamber for inspection revealed nothing remarkable, just the dark coating found elsewhere in the combustion chamber. A Bosch glow plug was also removed and found to be in good condition. The filament is sealed within a protective shroud, and the life of these is said to be indefinite.

Aluminum cylinder head was free of warpage, and gasket was intact. This layer of soft carbon coated combustion chambers. Mottled appearance of valve seats is due to soft carbon flakes. Swirl chamber and glow plug were also blackened but in perfect condition.
