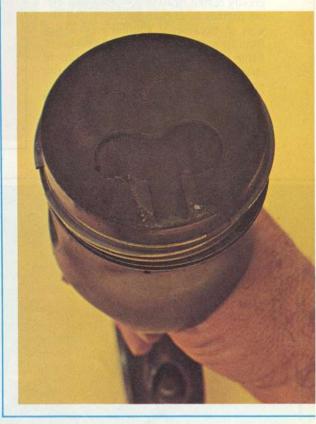
On removal of the aluminum cylinder head, the appearance of the combustion chambers was quite different from that of gasoline engines. There was a thin, soft, sooty, black film of carbon everywhere. Peugeot says this is typical and normal and that combustion chamber deposits don't build up with mileage in diesel engines the way they do in most gasoline engines. This self-cleaning action accounts no doubt for the smoke seen at times in diesel exhausts.

Opening a swirl chamber for inspection revealed nothing remarkable, just the dark coating found elsewhere in the combustion chamber. A Bosch glow plug was also removed and found to be in good condition. The filament is sealed within a protective shroud, and the life of these is said to be indefinite.

The intake valves and seats had bright, smooth seating surfaces and were in excellent condition. The exhaust valve seats had a mottled appearance from their steady diet of soft carbon particles but little in the way of actual wear and no indication of burning. The exhaust valves present a markedly different appearance from their counterparts in gasoline engines of this mileage. They are dark and look as if they've never been hot, whereas those from gasoline engines are brownish-red because of the much higher exhaust gas temperatures. All valves were found to be snug in their guides and there was no evidence of loss of oil through the guides.

Aluminum cylinder head was free of warpage, and gasket was intact. This layer of soft carbon coated combustion chambers. Mottled appearance of valve seats is due to soft carbon flakes. Swirl chamber and glow plug were also blackened but in perfect condition.
